**SAS Superstructure**

Location: 04-SF-80-13.2 / 13.9

Daily Diary Report by Bid Item

Diary #: 833 Const Calendar Day: 325 Date: 25-Apr-2013 Thursday

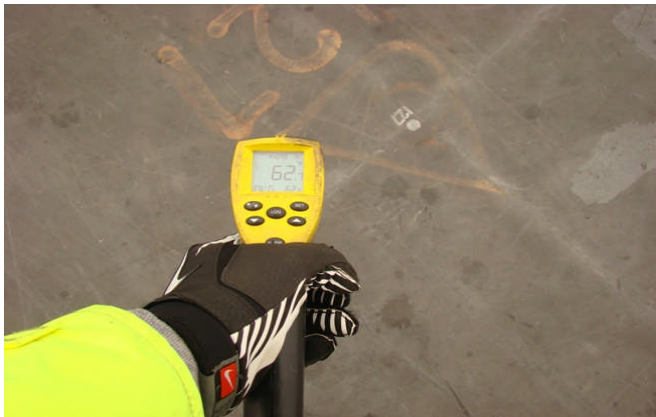
Average steel temperature measured at the end of the survey seen near panel point EPP127CL.

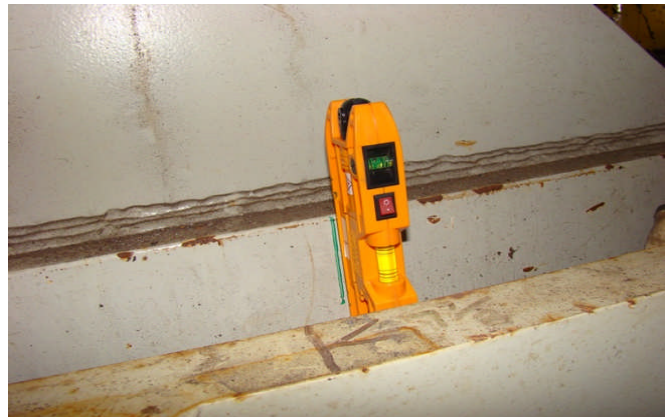
Laser level placed plumb in the longitudinal orientation on the Temp. Bearing No. 1 south foot assembly used to measure translation between the roller

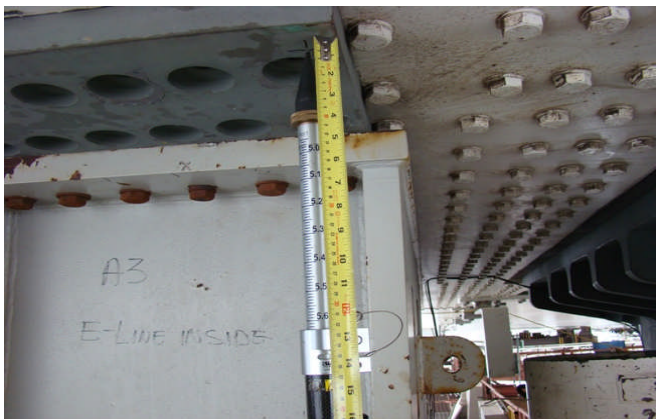
Typical measurement from the bipod pole clamp (silver section) to the Temp Bearing steel plate.

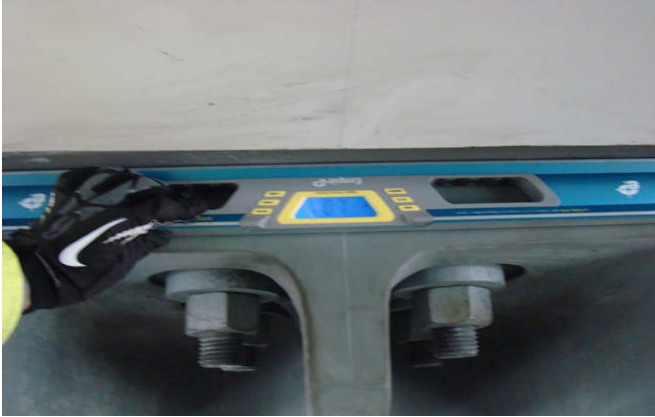
increase much as the measured temperature was 63F. Also it should be noted that both Skyway/east end SAS OBG traveller trolleys were erected onto the rails near Hinge A. However the concrete for the expansion joint at AW has not yet been placed. Finally the SMART level was placed on the south side of permanent bearings B1 and B2 as another check for rotation at Pier E2. Both measurements were 0.7 degrees clockwise looking north from the Pier E2 centerline.

Measurement taken on the south side of Bearing B2 of 0.7 degrees.

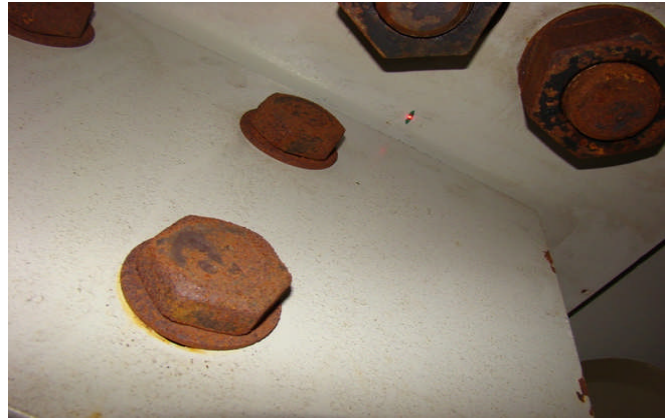
Initial mark placed with the laser level to measure translation on the south face of Temp. Bearing No. 1 foot assembly.

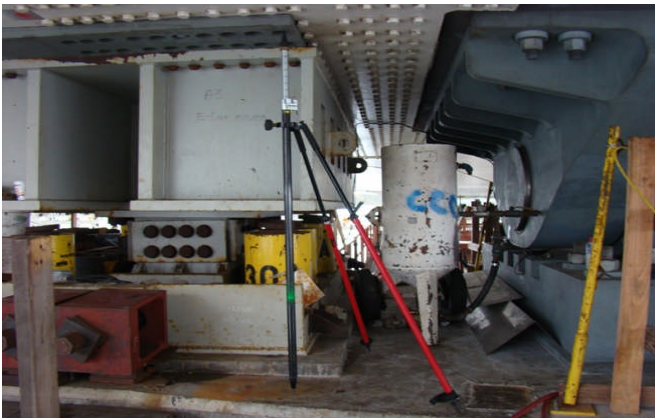
Bipod placed on the southwest corner of Temporary Bearing No. 3 to measure rotation of the bridge at pier E2, marks were made on the concrete & steel
